Atlantic Division, Naval Facilities Engineering Command

Abstract of an Accident

Accident Type: Fall

Type of work: Reinforcing Steel

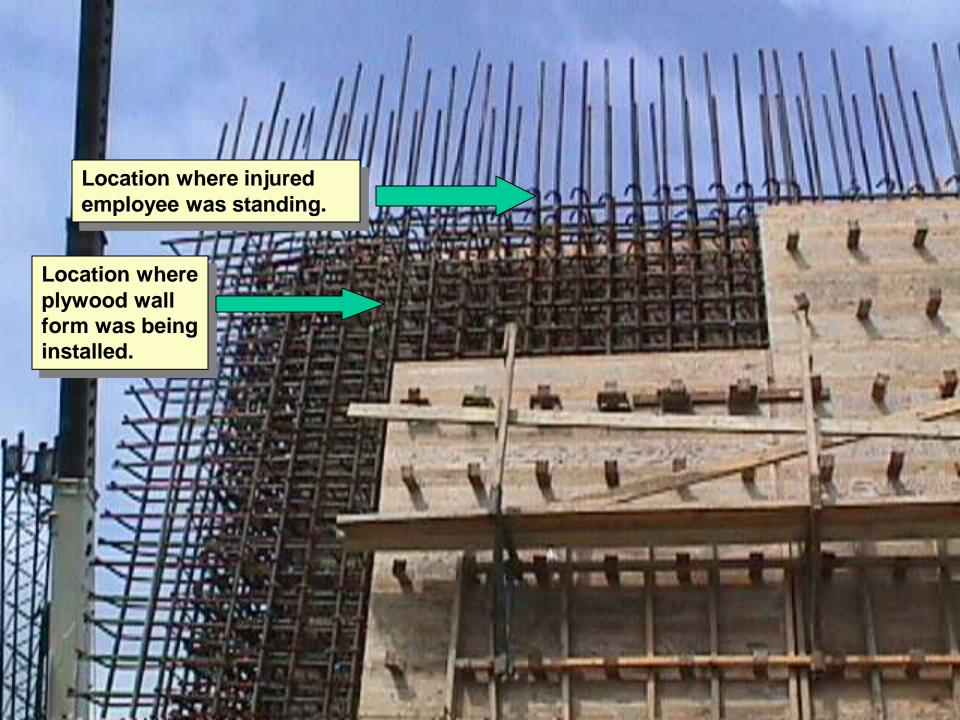
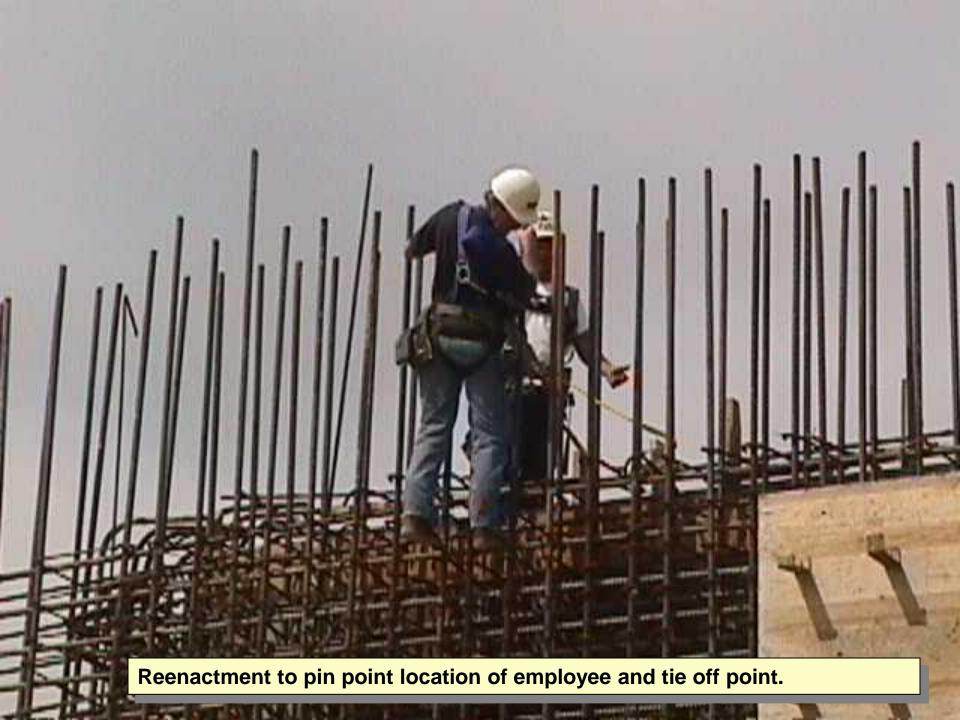
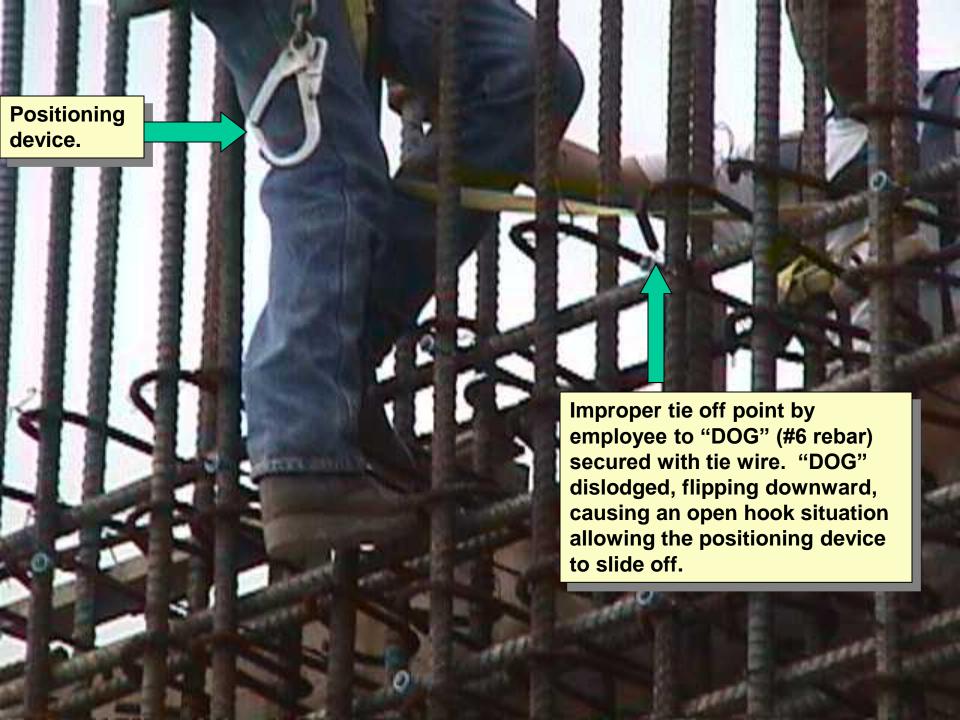
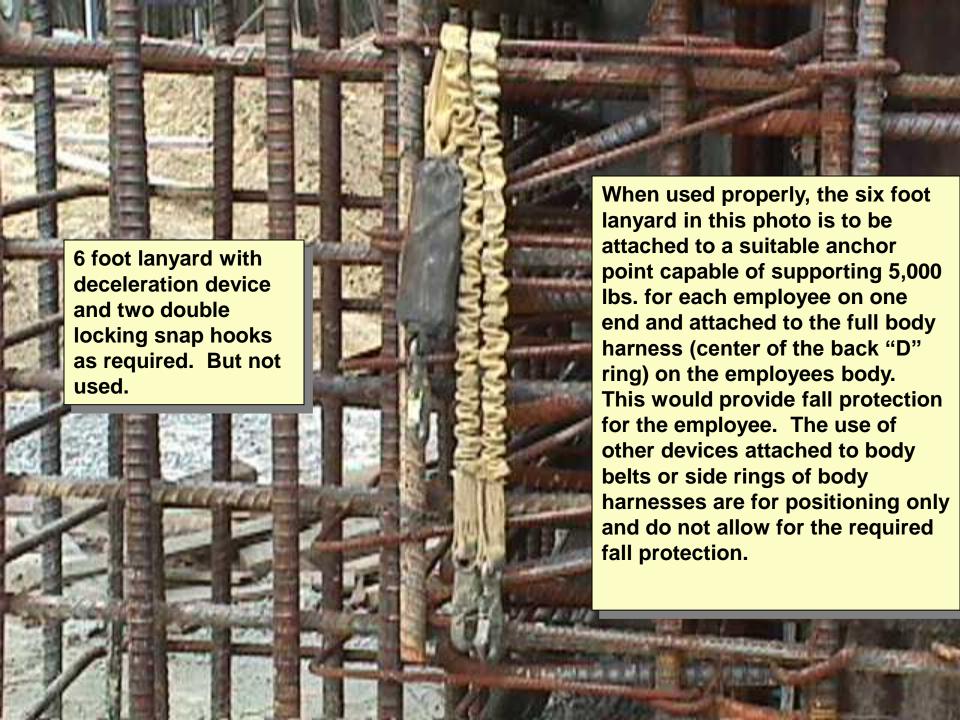
DESCRIPTION OF MISHAP Three steelworkers were in the process of installing an exterior 4'X8' sheet of plywood form for a concrete wall placement 20' above grade. Two workers held the plywood sheet in place while the injured employee, inserted the wall ties from a position above the plywood sheet being installed.

The worker fell as a result of improperly used fall protection equipment.

<u>CAUSE</u> The worker used a positioning device as his only means of fall protection and attached to an inadequate anchor point. The lesson to be learned from this accident is that although standards allow reinforcing steelworkers to use body belts with positioning devices while tying reinforcing steel, this must be used in conjunction with a full body harness attached with a lanyard designed to limit the employee fall distance to no more than six feet affixed to a suitable anchor point. As we know, and must review, a 100% fall protection rule exists for work over six feet. This being the case, employees may well be required to utilize two lanyards in addition to the positioning device to allow for employee movement from one location to another. The positioning device is not acceptable as the primary means of fall protection additional harness and lanyards are

<u>needed</u>. Please use the following slides to assist in depicting the event.
